PDX Inspect

Inspection and Consulting Services

GENERAL INSPECTION INFORMATION

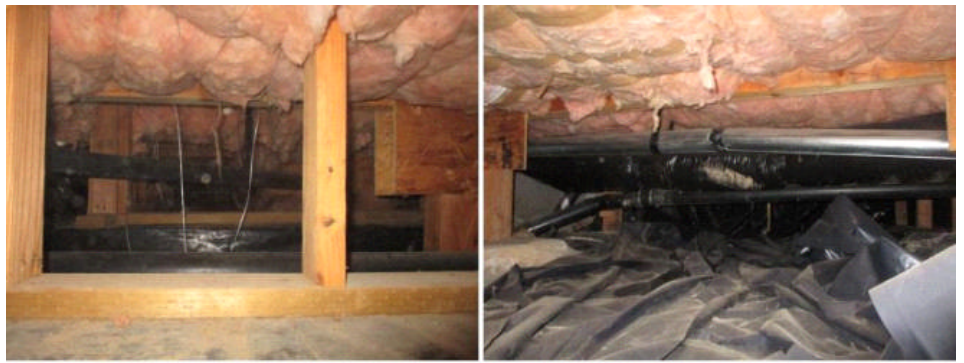
There is standing water in the crawlspace under the kitchen, at the rear garage foundation wall. It would be recommended to install a crawlspace access door in the rear garage wall to more easily access the crawlspace. Additionally a sump pump would be recommended in this low area and an access near the sump location will make maintenance of the sump easier.

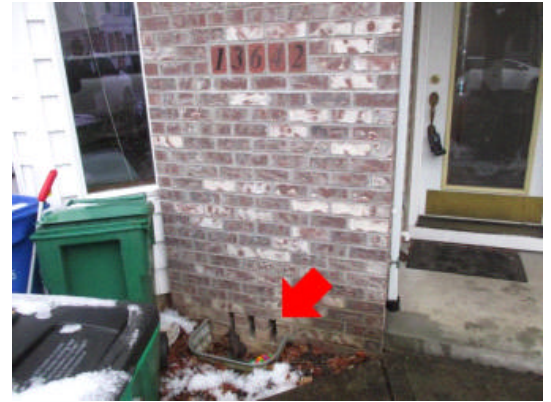
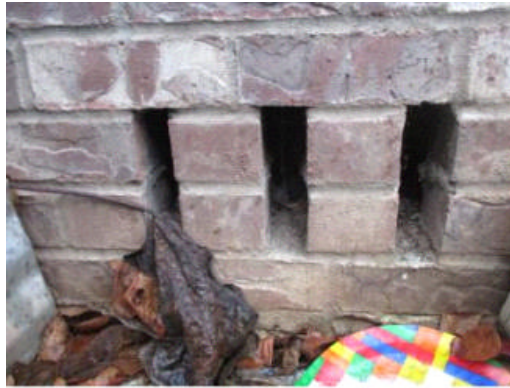
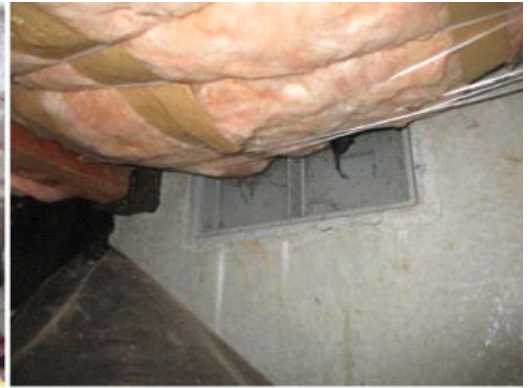
There are small openings in the brick facade at the front foundation vents, making the vent covers difficult to access. The foundation vents are closed and would be recommended to be opened.

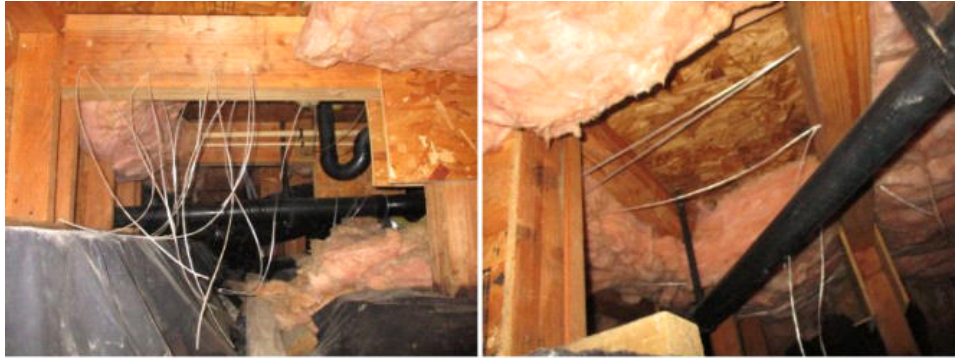
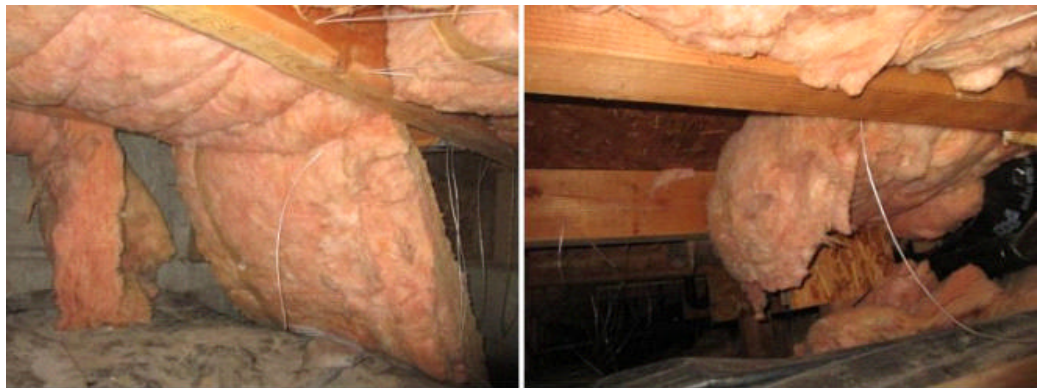
INSULATION & DUCTING There are numerous areas throughout the crawlspace where the floor insulation has been knocked or pulled down from the supports. It would be recommended to re-install and to secure these areas. This is leaving some sections of the plumbing supply piping exposed and un-insulated.

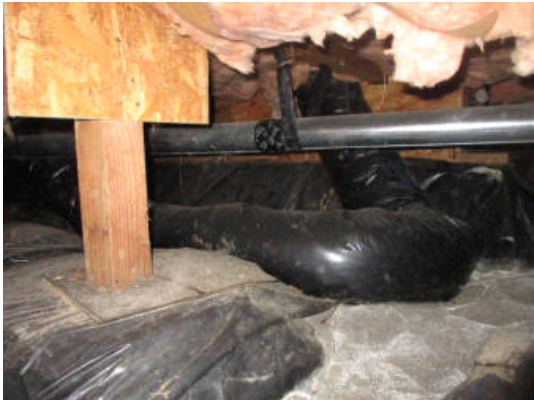
The furnace ducting is lying on the ground under the front office, in the crawlspace. The ducting should be raised up off of the ground and supported.

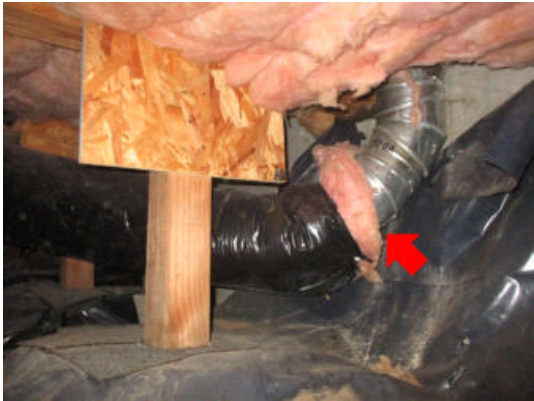
There is debris noted in the ends of a number of the ducts, near the floor registers, around the crawlspace. This was noted by knocking on the ducting and feeling or hearing debris inside of the ducting. It would be recommended to have the ducting cleaned or vacuumed to remove any and all debris.

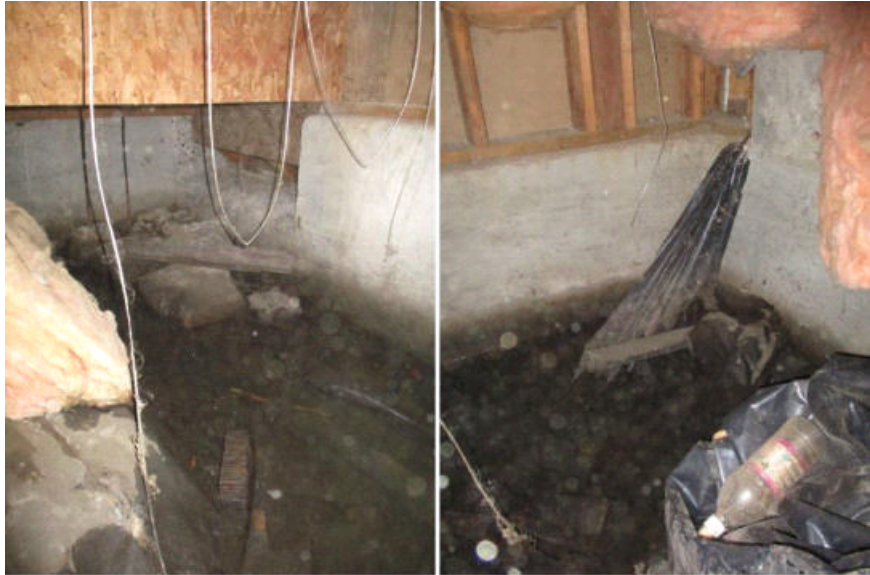
There is standing water in the crawlspace under the kitchen, at the rear garage foundation wall.

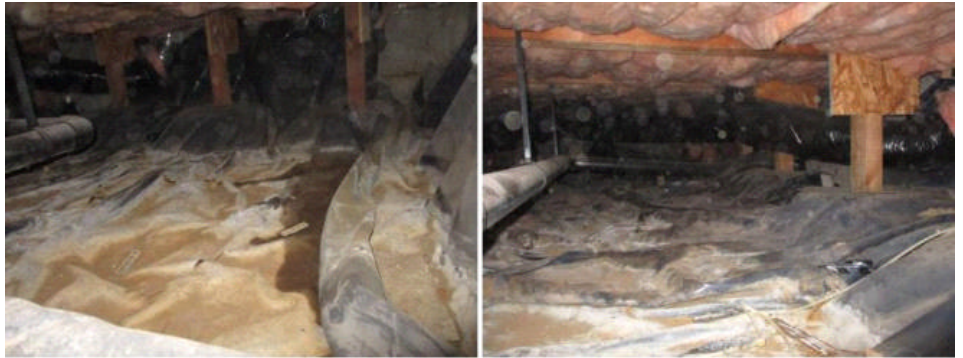
There is also a low area under the Western half of the living room area. It would be recommended to trench from this low area to the kitchen low area to allow drainage. It would be recommended to install a crawlspace access door in the rear garage wall to more easily access the crawlspace. Additionally a sump pump would be recommended in this low area and an access near the sump location will make maintenance of the sump easier.

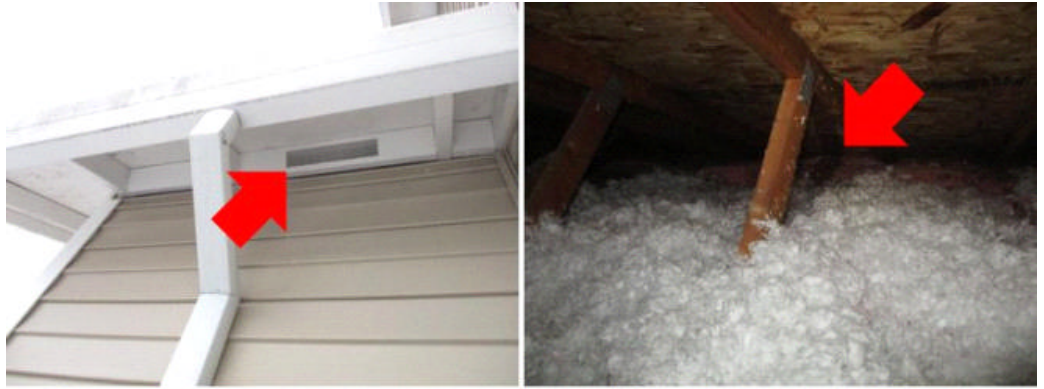
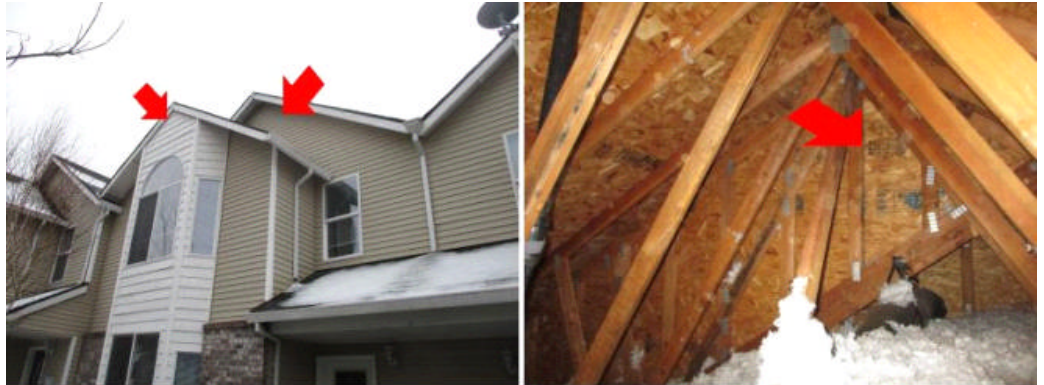
Changes to the existing venting would be recommended.

It would be recommended to install gable end vents, in the gable end walls to increase the flow and amount of ventilation, and/or to consider installing a thermostat controlled attic fan.

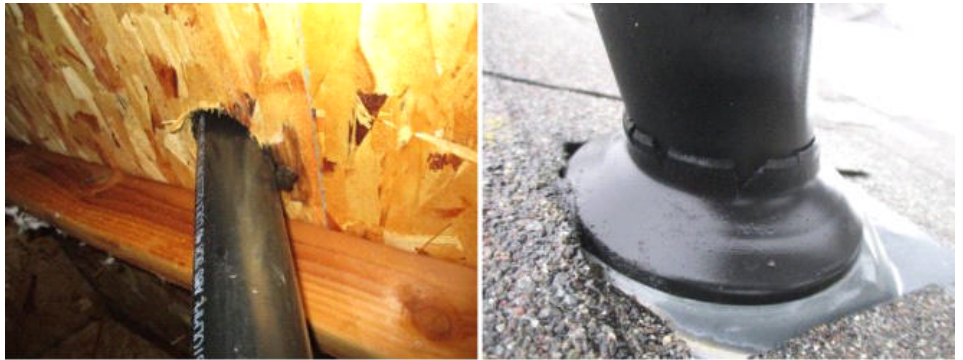
There is leaking around the plumbing vent penetrations through the roof. The plumbing vents are split and damaged.

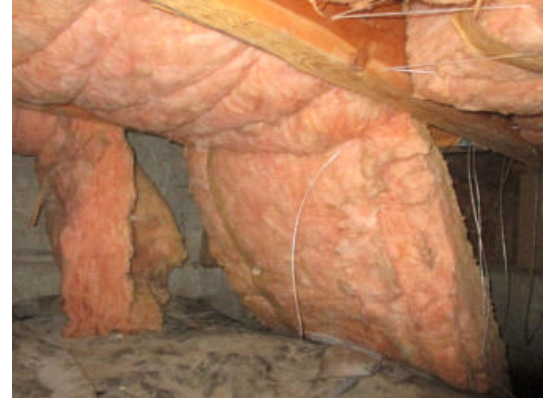
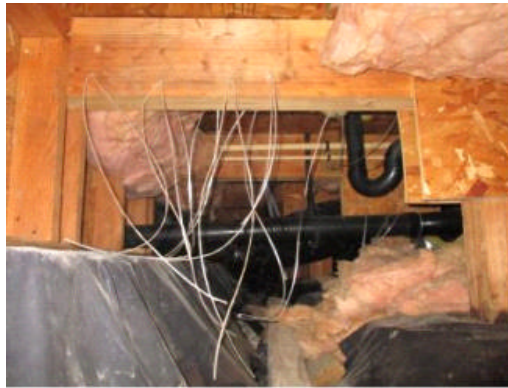
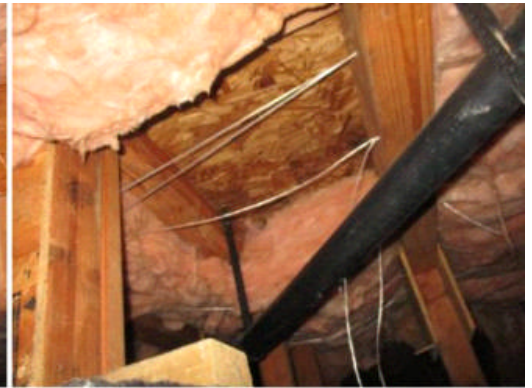
There are numerous areas throughout the crawlspace where the floor insulation has been knocked or pulled down from the supports. It would be recommended to re-install and to secure these areas. This is leaving some sections of the plumbing supply piping exposed and un-insulated.

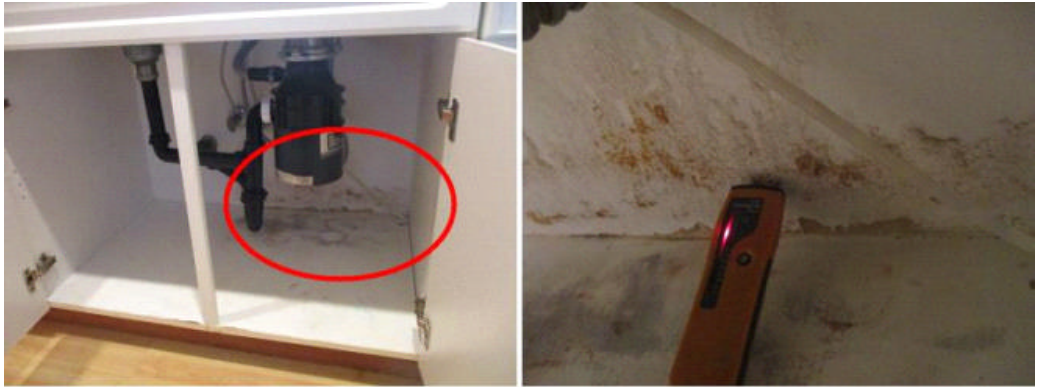
The base of the cabinet and the wall in rear of the under sink kitchen cabinet is water damaged and had over 50% moisture content before the kitchen sink or dishwasher was ran. The house has been vacant and the water has not been run. The wet wall indicates that there is a minor leak in a supply line or piping fitting at or inside of the plumbing wall; however, no clear leak is visible. The wet wall material is starting to host a mold growth. The wet wall material should be removed, the leaking or source of moisture located and repaired, the moisture damaged mitigated, and the wall and cabinet repaired as necessary to address further leaking, moisture damage, and mold.

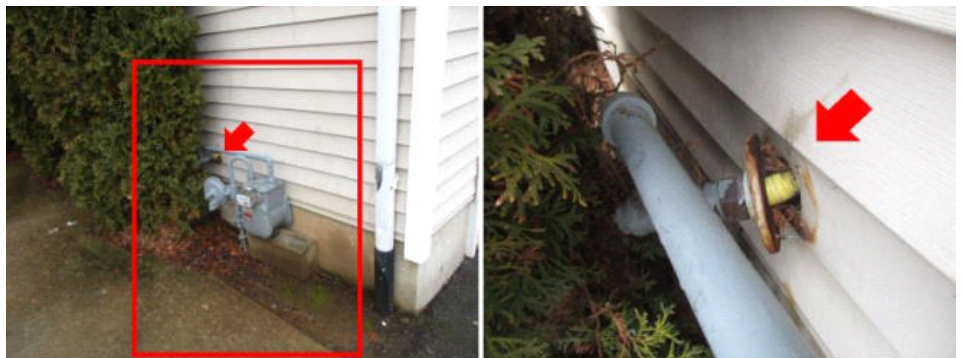
There is no bollard or safety post in front of the gas meter to protect it from car collisions

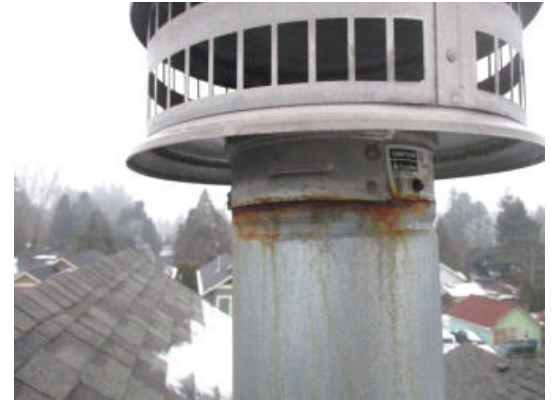
There is a significant build up of efflorescence and evidence of condensation leaking from the joints of the furnace flue. This is an indication of improper combustion in the furnace and it typically an indication of dirty furnace filters, causing the exhaust to be excessively hot.

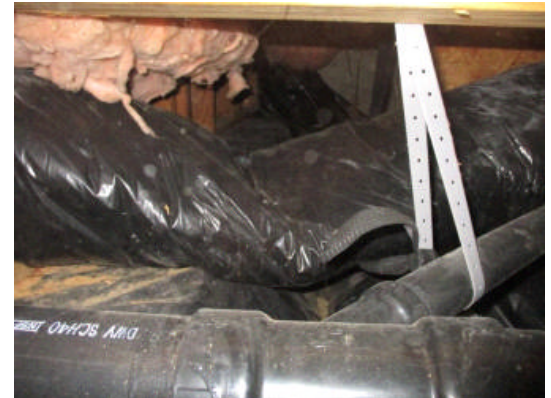
There is a crushed duct under the main floor bathroom.

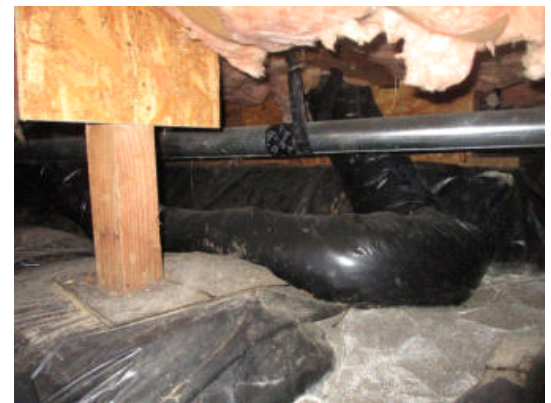
The furnace ducting is lying on the ground under the front office, in the crawlspace. The ducting should be raised up off of the ground and supported.

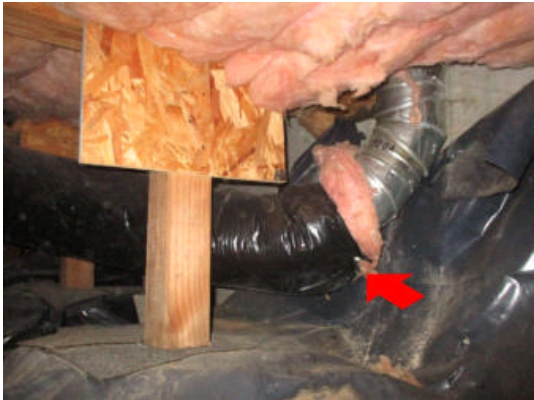
There is debris noted in the ends of a number of the ducts, near the floor registers. It would be recommended to have the ducting cleaned or vacuumed to remove any and all debris.

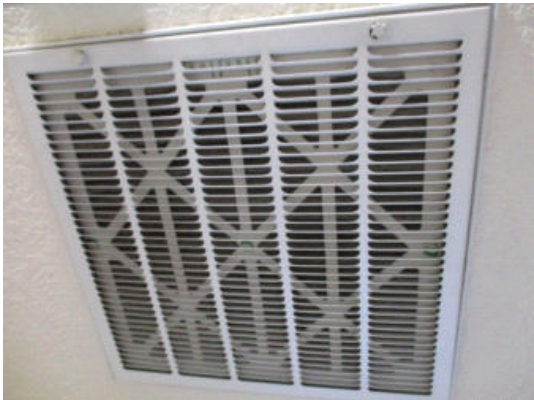
The furnace filter(s) are dirty and should be changed or cleaned.

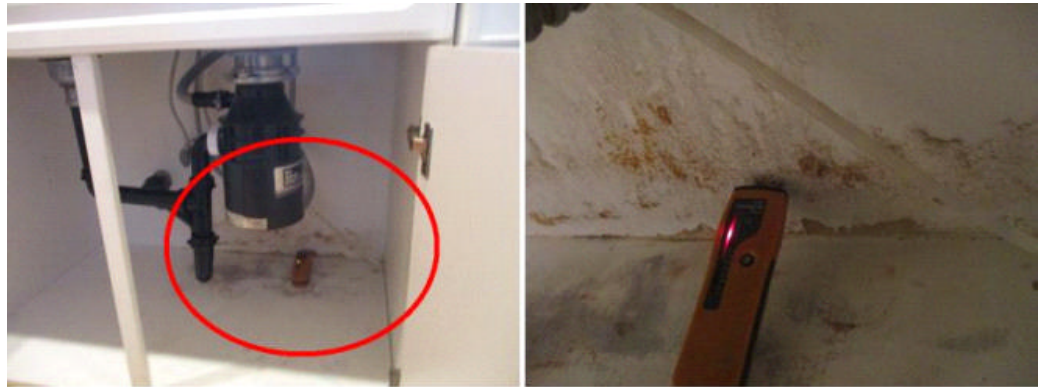
The base of the cabinet and the wall in rear of the under sink kitchen cabinet is water damaged and had over 50% moisture content before the kitchen sink or dishwasher was ran. The house has been vacant and the water has not been run. The wet wall indicates that there is a minor leak in a supply line or piping fitting at or inside of the plumbing wall; however, no clear leak is visible. The wet wall material is starting to host a mold growth. The wet wall material should be removed, the leaking or source of moisture located and repaired, the moisture damaged mitigated, and the wall and cabinet repaired as necessary to address further leaking, moisture damage, and mold.

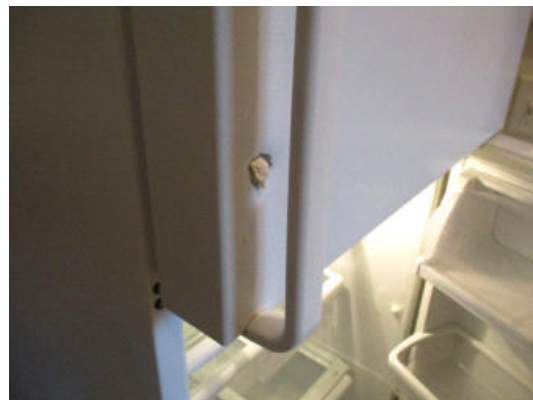
The fridge door appears to have incorrect handles, leaving a hole in the door face.

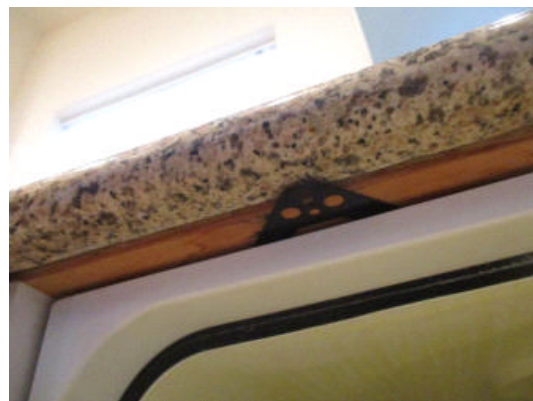
GENERAL CONDITION: Good, with exceptions
The dishwasher is not secured or connected to the countertop or cabinets.

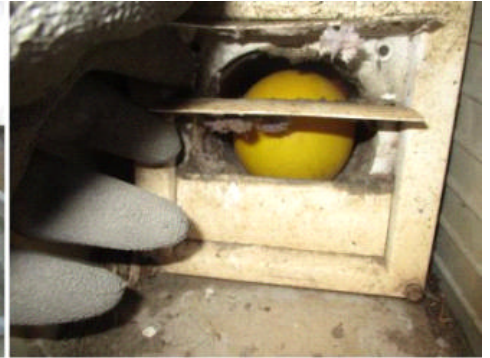
VENTING & TYPE: Vented / Ducted Out: Yes, Ducting Type : Solid Metal Ducting
There is a plastic ball inside of the dryer duct, which is obstructing air flow and creating a build up of lint in the ducting, which is considered a fire hazard. The ball should be removed and the dryer duct should be cleaned or replaced.

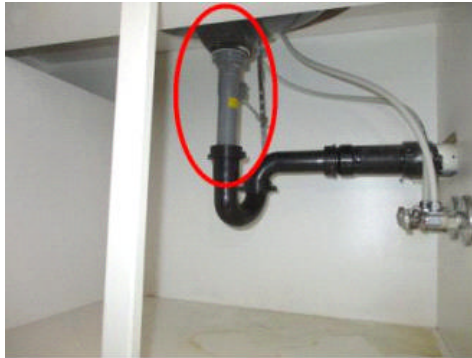
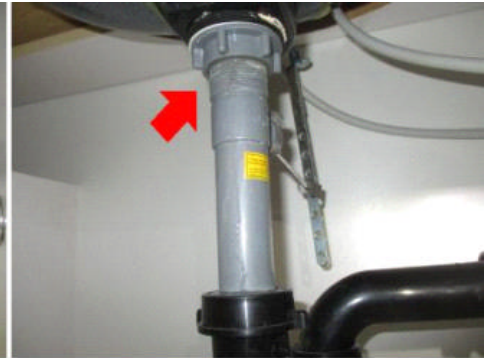
There is leaking noted at the connections of the drain piping under the sink. It would be recommended to have the leaking piping repaired or replaced.

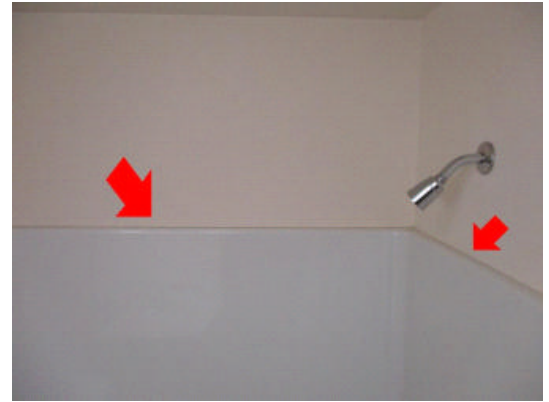
There is unpainted sheetrock above the shower surround, and no caulking, between the surround and wall, to prevent wicking or seepage around the top of the surround. It would be recommended to caulk and seam between the enclosure and wall and re-paint the sheetrock around the top of the enclosure, to prevent moisture intrusion.

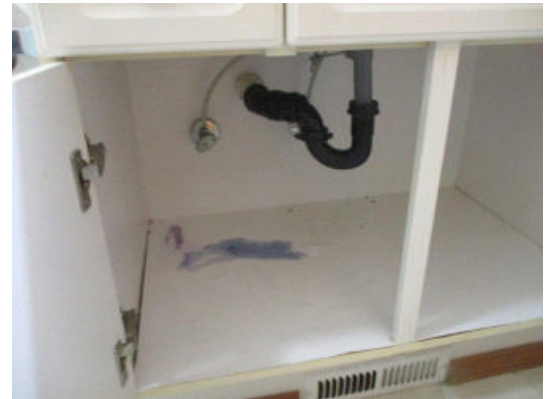
There is some minor swelling and water damage to the base of the cabinet under the sink due to water leaking and collecting under the sink.

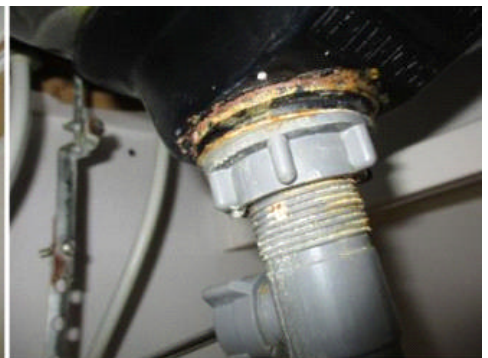
There is leaking noted at the connections of the drain piping under the sink. It would be recommended to have the leaking piping repaired or replaced.

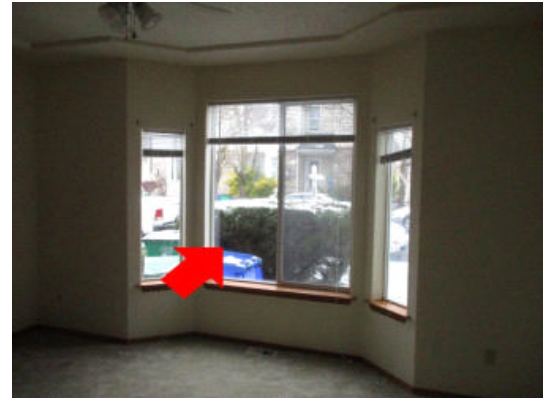
INTERIOR ISSUES: GENERAL CONDITION: Fair, with exceptions
There are broken seals between the panes of glass on the front office double pane window, which is allowing water vapor to collect between the glass panes. These windows appear fogged.
Other windows may also have broken seals, but may not be fogged or water stained. Some window will only show fogging at specific temperature difference between interior and exterior temperatures.

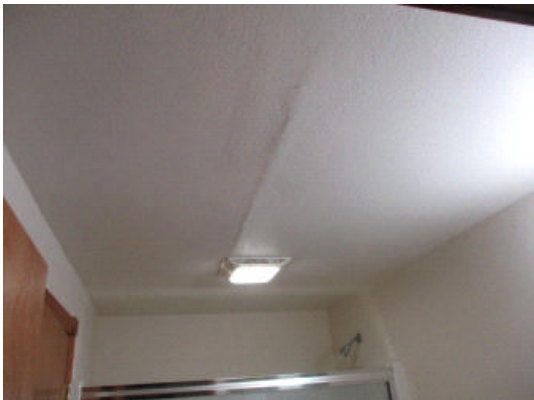
COMMENTS The main bathroom ceiling shows past water damage and patching. There is no current leaking or moisture.

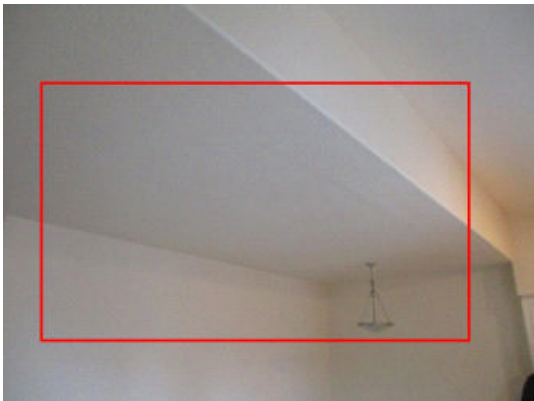
There is a very large patch in the living room ceiling. It is suspected there may have been a past leak from the upper bathroom. No leaking was noted at the time of the inspection.

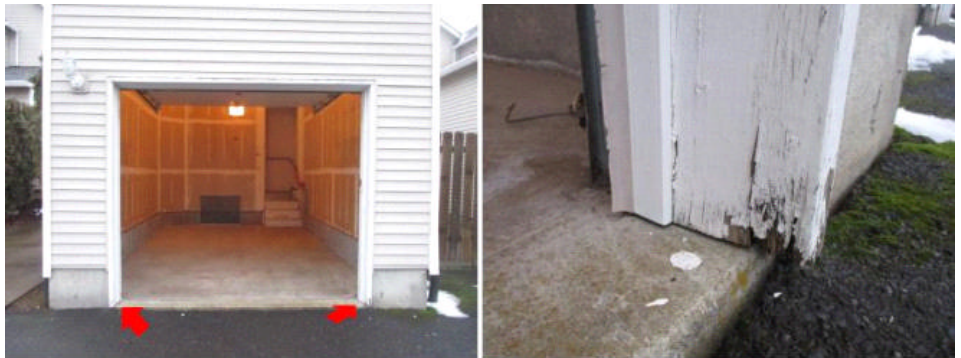
DOOR CONDITION: Fair, with exceptions
 Minor damage is noted.
 The garage door surround and trim is set in direct contact with the concrete driveway. The wooden trim is wicking moisture and has moisture damage and rot in the base of the surround. There is also some paint peeling and damage. It would be recommended to repair or replace the damaged trim base. It would be further recommended to cut or leave the bottom of the garage surround trim 1/4" to 1/2" above the ground level to prevent direct contact with the ground.

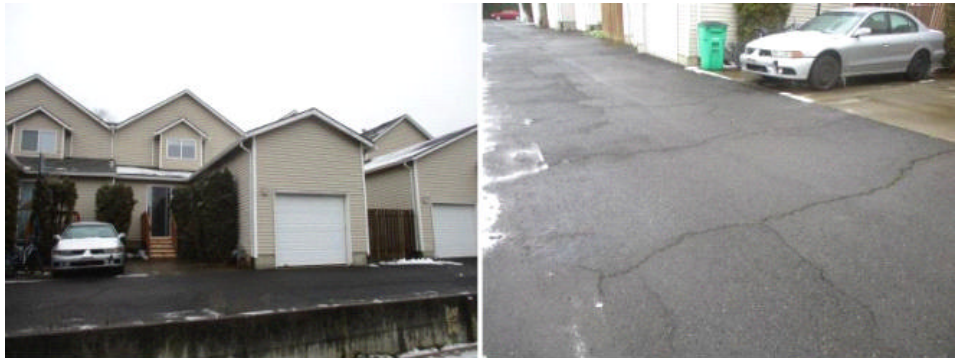
There is some cracked and settled sections of the asphalt driveway. This damage is not considered to be excessive, but will likely require repair within the next 3 to 5 years.

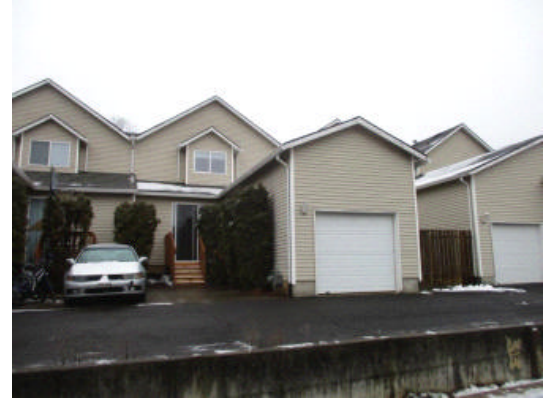
There are bushes along or against the side of the garage. Large bushes and tree branches should be kept trimmed away from the walls and roof to prevent wind related damage to the structure.

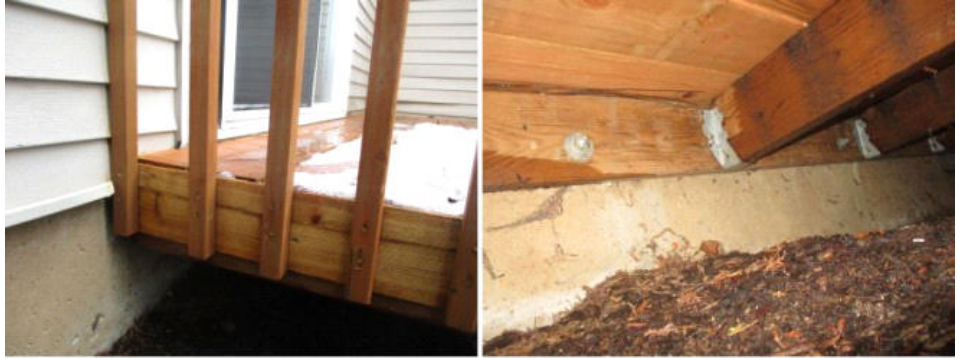
The deck ledger was installed over the top of the vinyl siding, which is an improper installation. The vinyl siding should not be anchored or fastened through due to expansion and contraction of the vinyl.

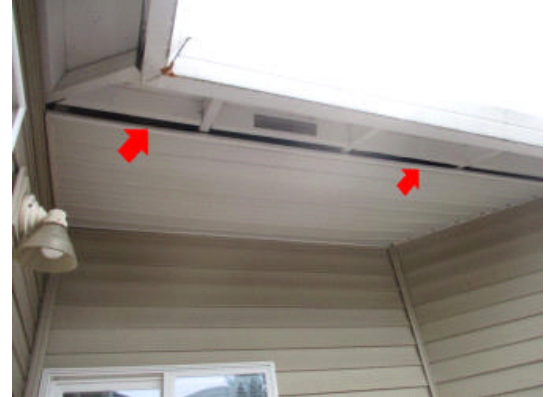
The soffit material of the rear soffit, above the deck, was too short and is leaving an open and unsealed gap at the edge of the soffit. It would be recommended to install screening at this gap to prevent birds from nesting in the soffit.

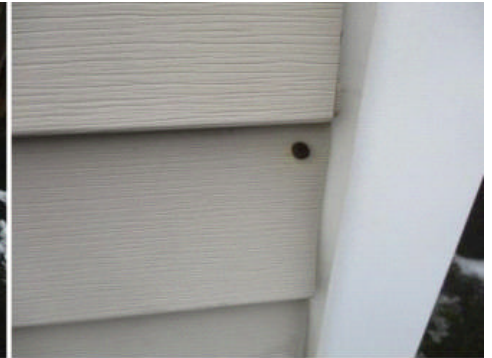
The siding on the front garage side walls was cut too short to fit properly in the J-channels. The siding was screwed to the wall. Vinyl and/or Metal siding should not have any fasteners secured through the siding.

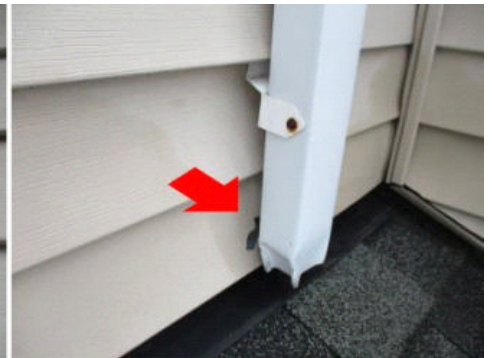
There are several holes and punctures through the siding. The damaged sections of siding should be replaced or properly patched.

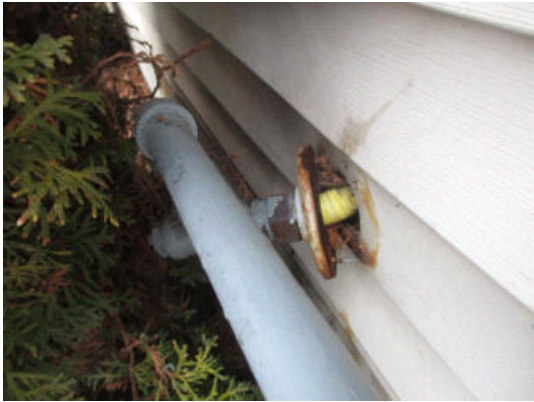
There is not a proper transition block outs or trim block to properly seal and secure the siding at the gas line penetration. Both vinyl and metal siding expand and contract very readily and caulking at penetrations is ineffective due to expansion and contraction of the siding that will break the seal of the caulking. Proper block-out have channels around the block-out to seal and secure the siding, leaving a single membrane that can be sealed.

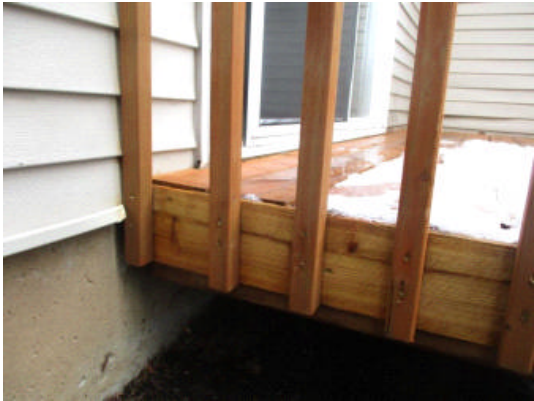
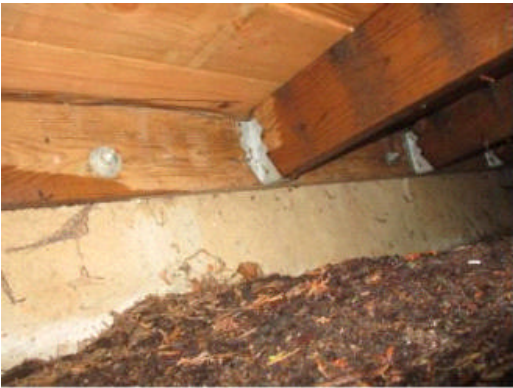
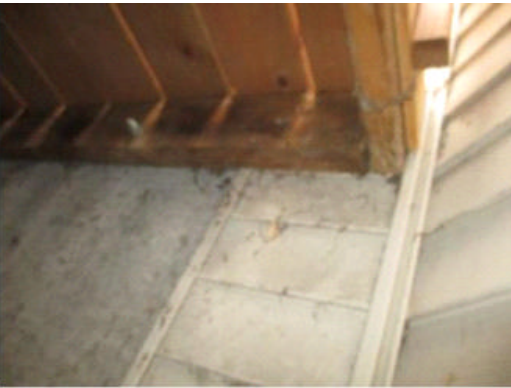
The deck ledger was installed over the top of the vinyl siding, which is an improper installation. The vinyl siding should not be anchored or fastened through due to expansion and contraction of the vinyl.

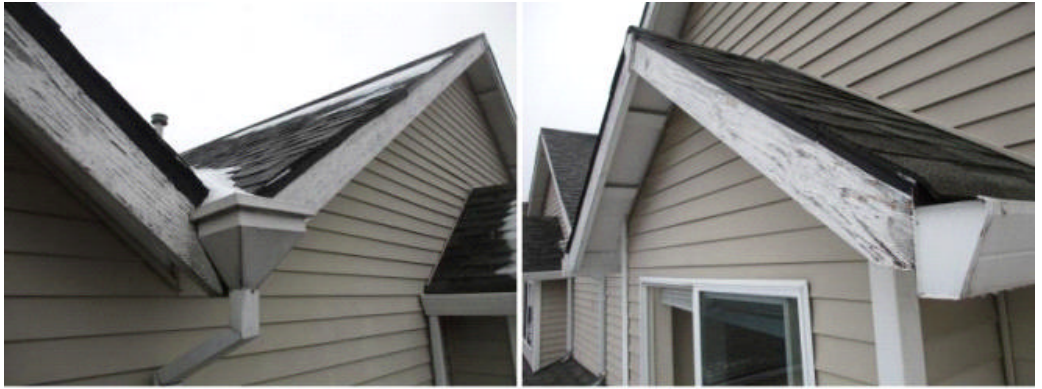
PAINT CONDITION: The paint on the house appears to be in good to fair condition. The exception is that of some peeling paint on window and doorframes. The paint on the varge rafters is cracked and peeling, and needs to be re-painted.

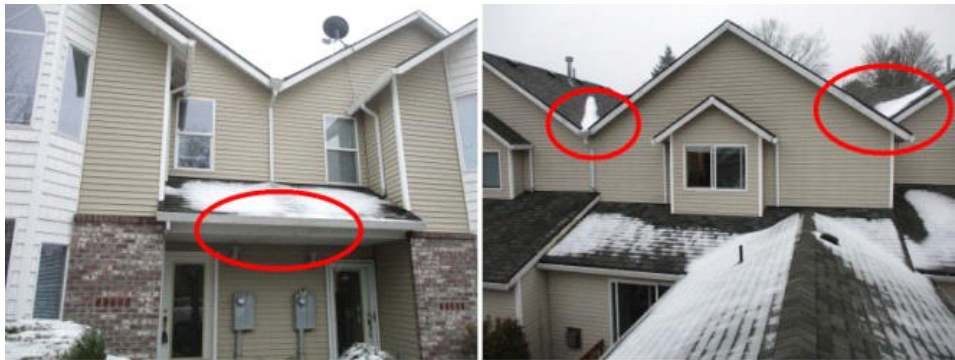
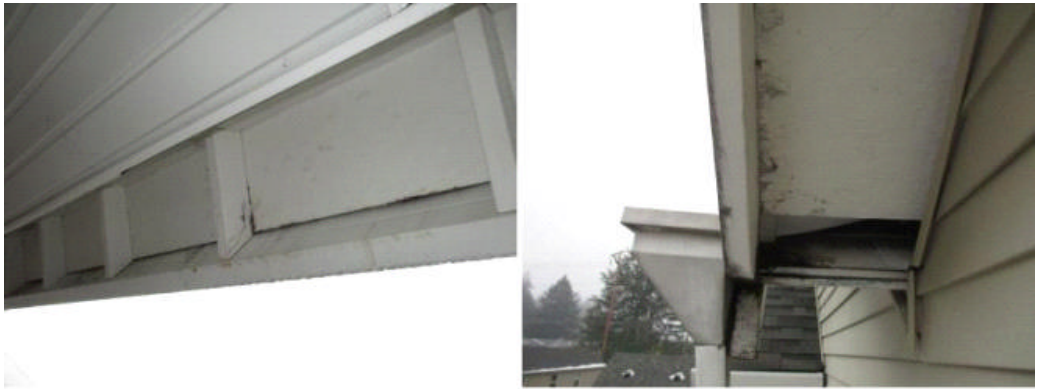
There are water stained and paint damaged sections of soffit and fascia at the front porch, upper rear valley, and SE end of the upper rear gable. There is some water damage and/or rot in the perimeter edges of the soffits in areas around the house.

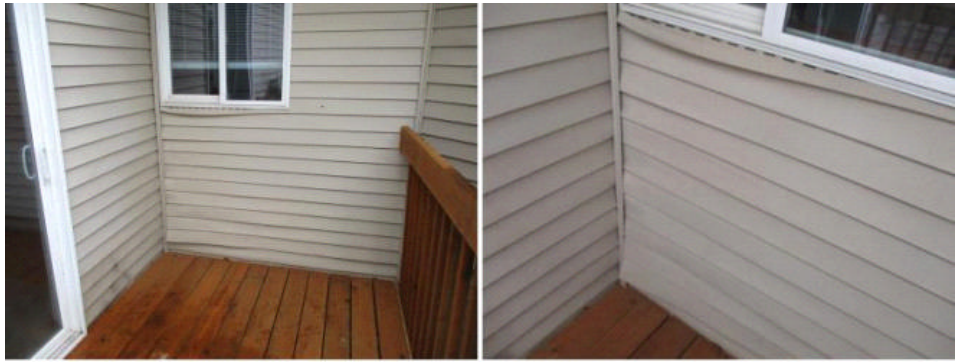
* GENERAL CONDITION: Fair, with exceptions noted above
There is melted and heat damaged siding at the rear deck due to a BBQ grill being placed too close to the siding.

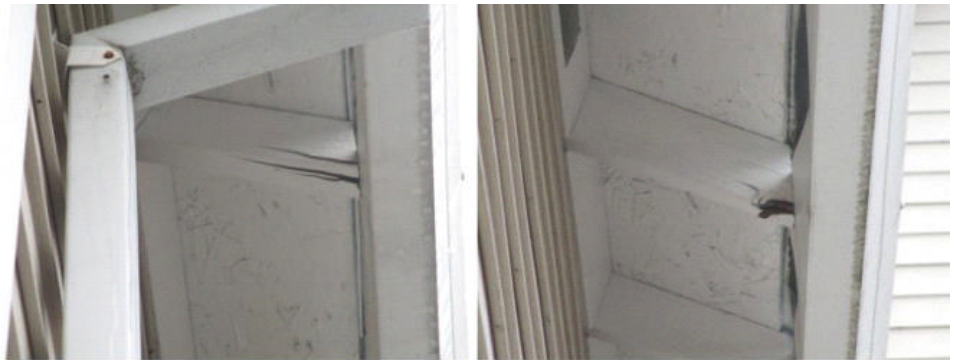
Several of the rafter tails along the Western side of the garage have been split by the gutter screws. The gutters appear to be secured by anchors in other rafter tails. The split rafter tails do not appear to be causing a structural deficit.

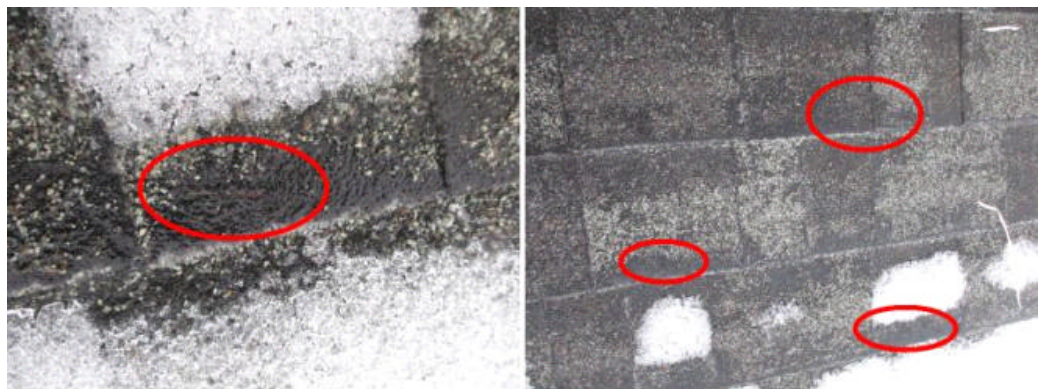
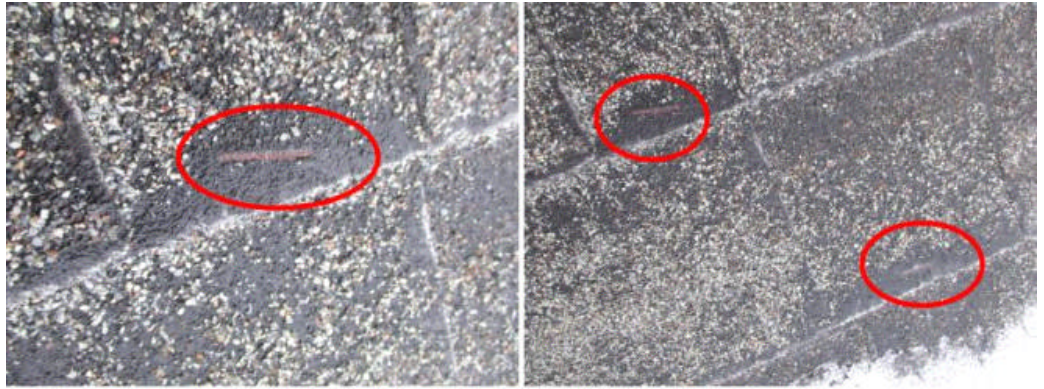
Some of the staples used to secure the roofing were not set flush, and are slightly raised above the surface of the shingles. This is causing wear spots and penetrations in the covered portion of the next course of shingles. This is found throughout the roof. This will diminish the life expectancy of the roofing and can cause leaking due to these roof penetrations. These staples should be removed or set flush and the roofing patched with a tin shingle, or the damaged tabs should be replaced.

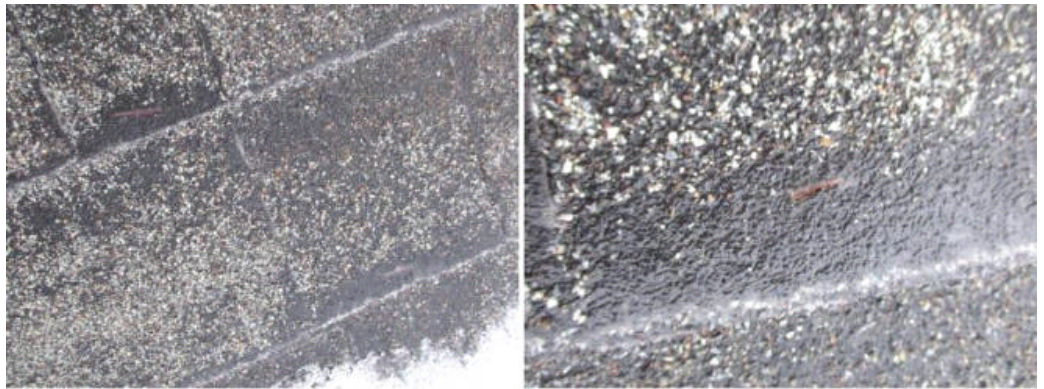
There are no signs of leaking, however these areas of roofing are expected to cause leaking within the next few years. Due to the damage to the roofing, the roofing material is considered to be at the end of its useful life expectancy.

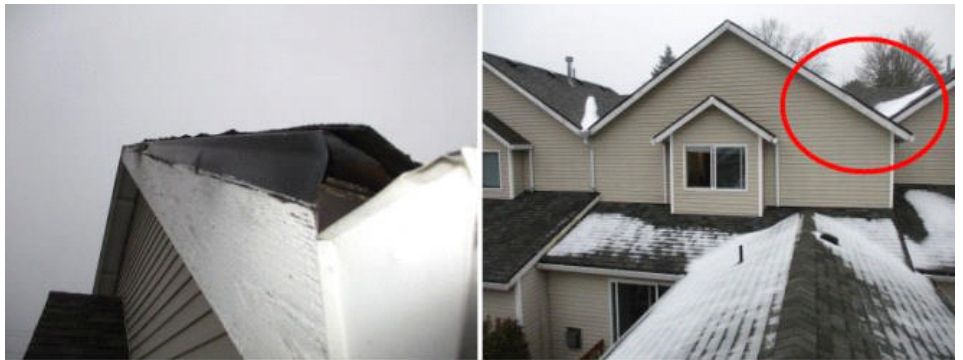
The edge flashing on the upper SE gable is raised, which is exposing the edge of the roof sheathing and bridge the roofing, which can cause tears and damage.

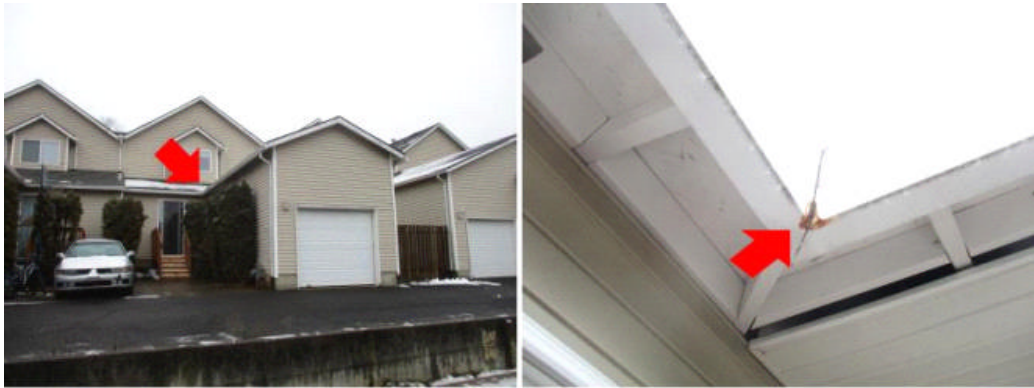
TYPE(S):	GUTTERS: Metal,	DOWNSPOUTS: Metal.
CONDITION:	GENERAL CONDITION: Fair, with exceptions There is leaking noted at some of the gutter joints or seams. This can create moisture issued and erosion round the structure. It would be recommended to reseal these joints. There are some loose or unsecured downspouts around the house. It would be recommended to properly secure the downspouts.
