PDX Inspect

Inspection and Consulting Services

GENERAL INSPECTION INFORMATION

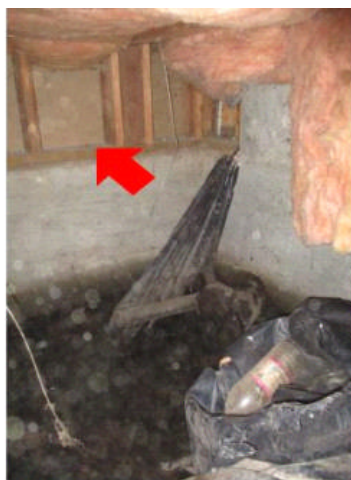
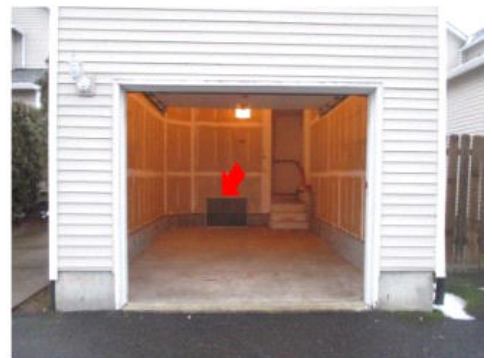
There is standing water in the crawlspace under the kitchen, at the rear garage foundation wall. It would be recommended to install a crawlspace access door in the rear garage wall to more easily access the crawlspace. Additionally a sump pump would be recommended in this low area and an access near the sump location will make maintenance of the sump easier.

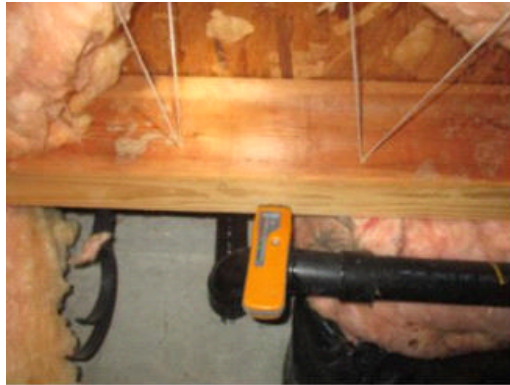
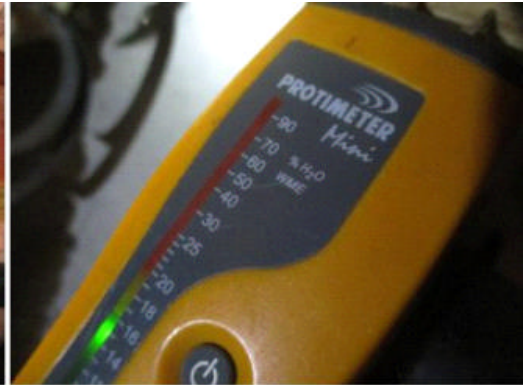
MOISTURE CONTENT

The moisture content range observed in the crawlspace was relatively even or consistent throughout the crawlspace. The observed moisture content was: 13% - 15%

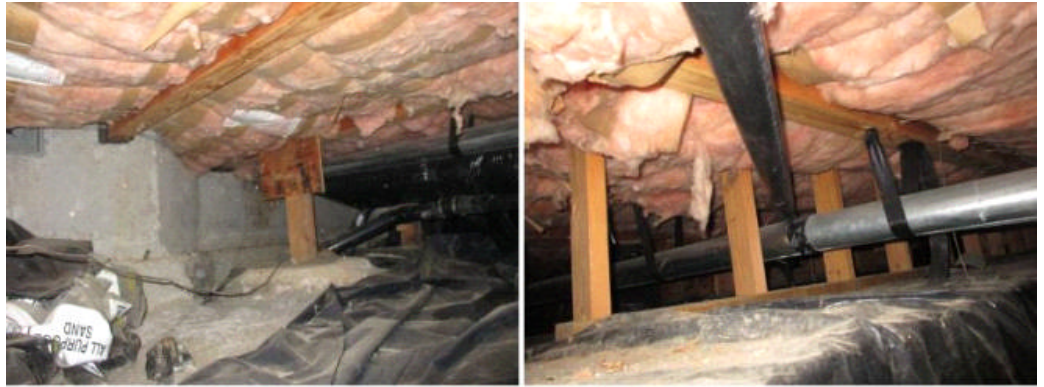
The structure and structural members appear to be in good condition. There is some visible cracking and/or deterioration to the concrete foundation. There are minor shrinkage or settlement cracks noted in areas around the foundation, which are expected and are not considered to be significant at this time. None of these cracks are shifted or listed and do not indicate signs of structural deficiency.

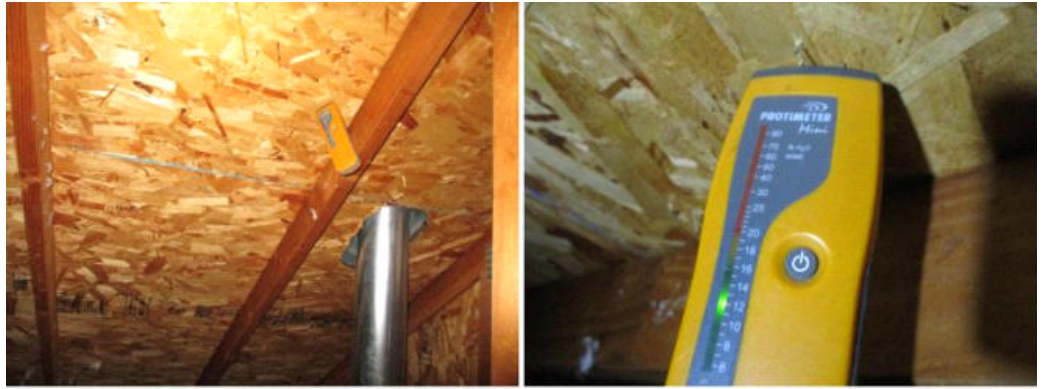
There is leaking around the plumbing vent penetrations through the roof. The plumbing vents are split and damaged.

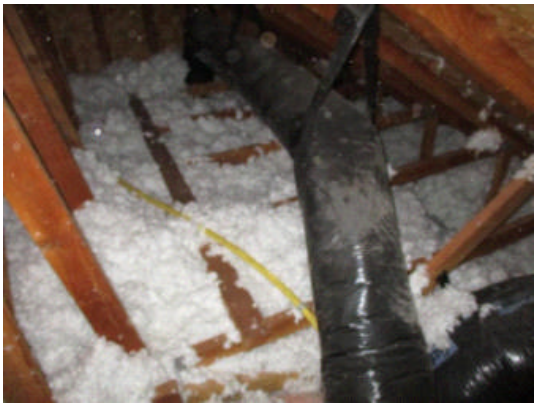
There is compacted or shifted areas of insulation in the attic due to "traffic" in the attic. There are foot trails through the insulation. This has diminished the thickness and R-Value of the insulation in these areas.

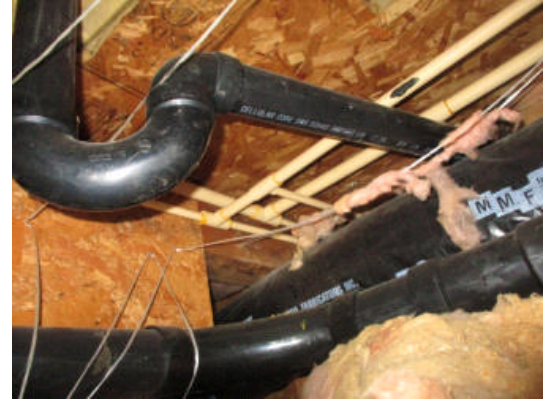
**INSULATION ON
PLUMBING:**

Yes, The piping is buried in the floor insulation.
There are areas of loose or missing insulation.

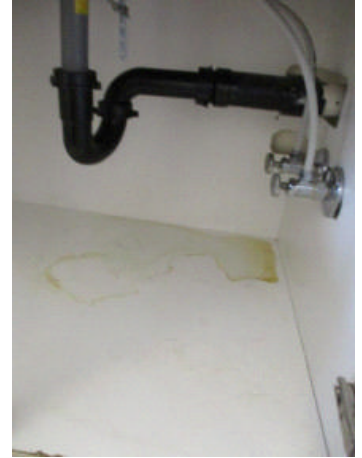
There is some minor swelling and water damage to the base of the cabinet under the sink due to water leaking and collecting under the sink.

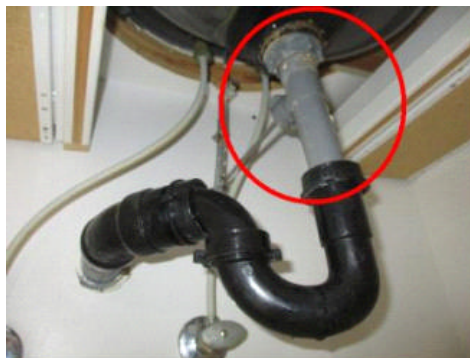
There is leaking noted at the connections of the drain piping under the sink. It would be recommended to have the leaking piping repaired or replaced.

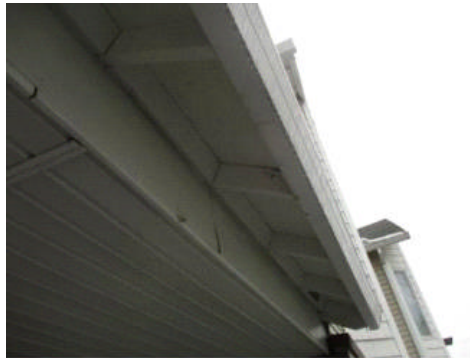
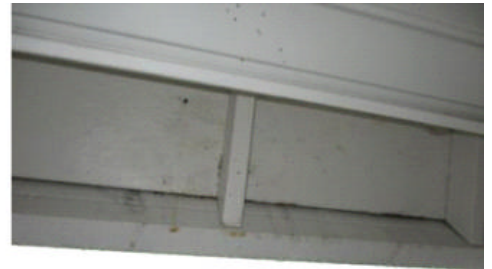
The porch appears to be in good or expected condition, with the following exceptions
There are water stained and paint damaged sections of soffit and fascia of the front porch roof, due to over flowing gutters and wicking along the edge of the soffit. There is some water damage and/or rot in the perimeter edges of the soffit.

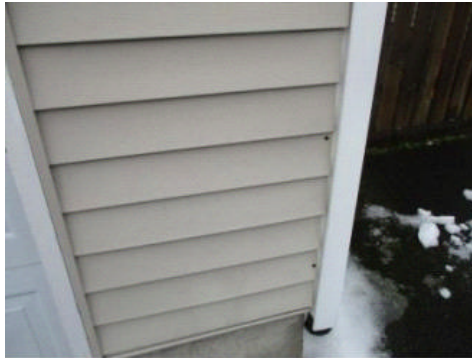
The siding on the front garage side walls was cut too short to fit properly in the J-channels. The siding was screwed to the wall. Vinyl and/or Metal siding should not have any fasteners secured through the siding.

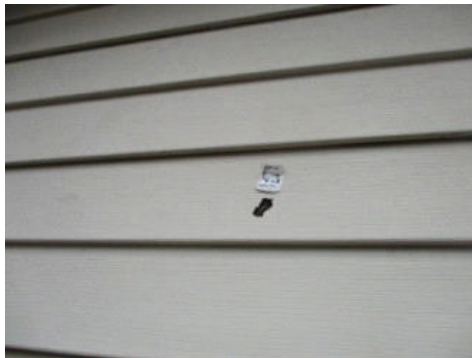
There are several holes and punctures through the siding. The damaged sections of siding should be replaced or properly patched.

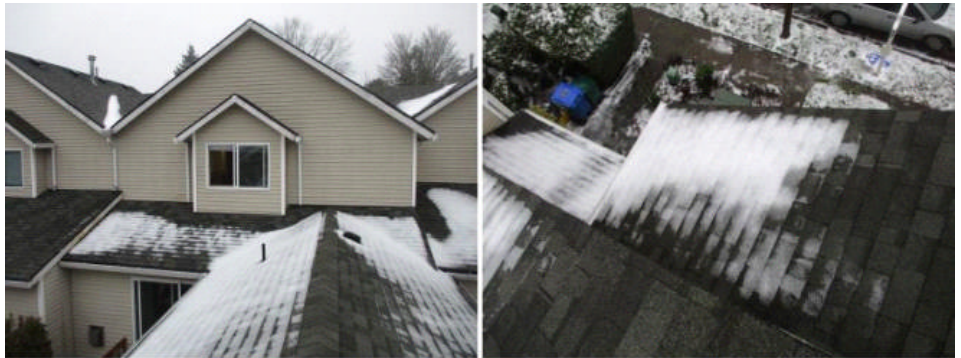
ROOF ACCESS: The roofing surface was obstructed by snow. It would be recommended to have the roofing condition evaluated when the snow melts and the roofing can be fully observed Please make arrangements with our office to re-schedule the roof inspection when snow cover is gone.
